How to remove the etching left by a bird dropping with ScratchX

At the recent San Diego Viper Detailing Clinic here at Meguiar's in Irvine, one of the club members showed me where a bird left him a little present on the hood of his black Viper. Below is a picture of the car after the Meguiar's polishing system...

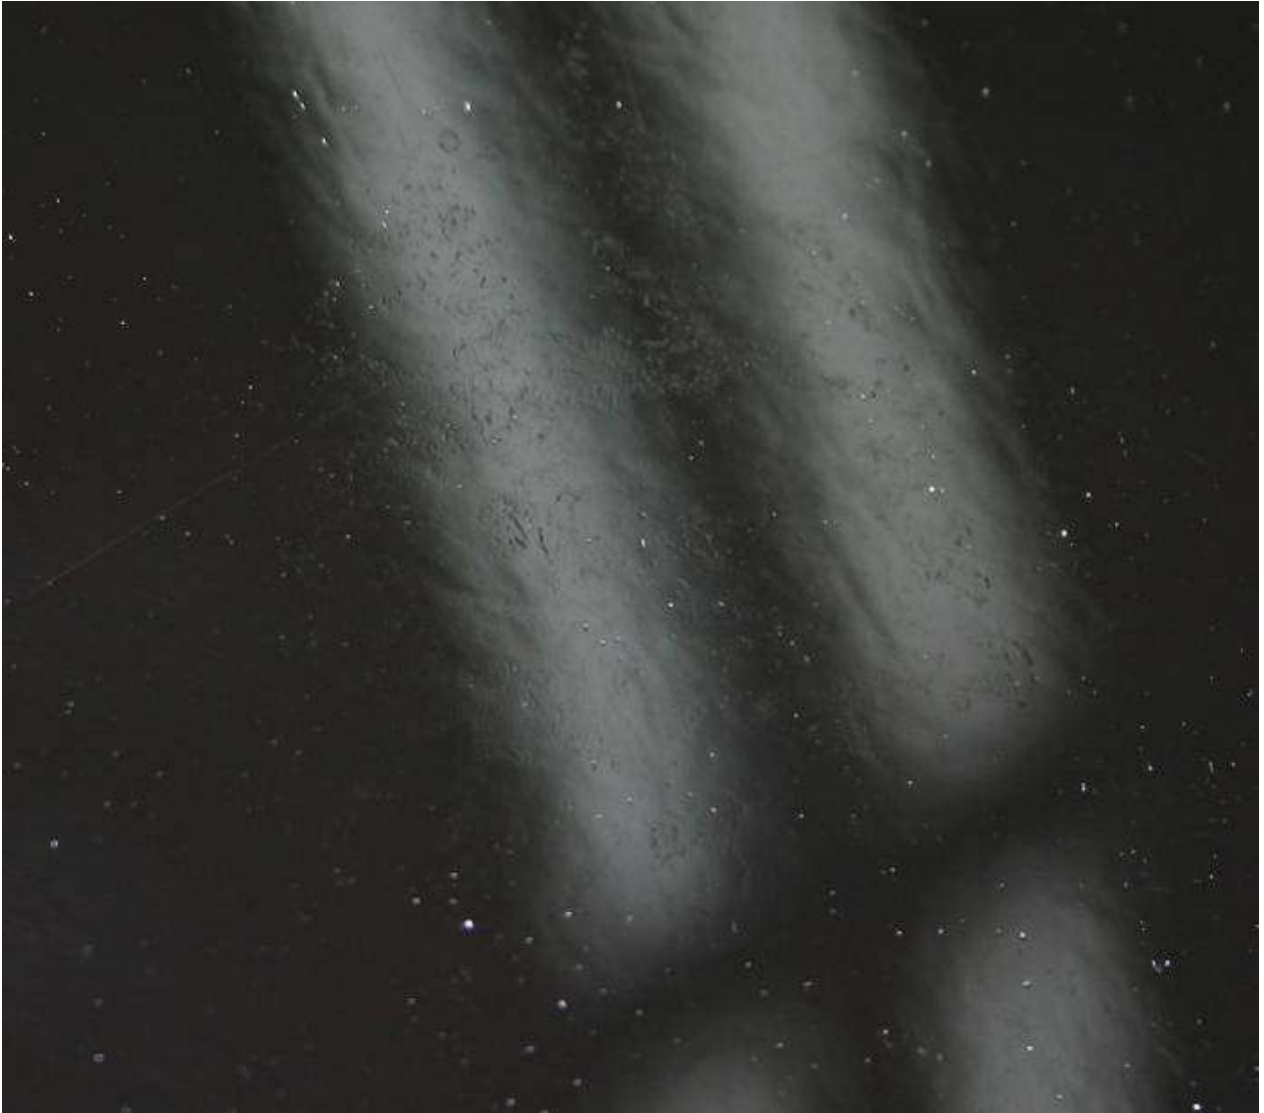
After ScratchX

Note: The above *after* picture was taken after three applications of ScratchX that were thoroughly worked into the finish. Each application removed a little more paint and thus removed a little more of the etching. After three applications the etching was no longer visible from a couple feet away. We stopped here because we were going to machine polish the entire finish using the [G-100a](#).

At the time the above after picture was taken, neither any polish or wax had been applied. The results will only get better with an application of a pure polish and then a couple of coats of wax.

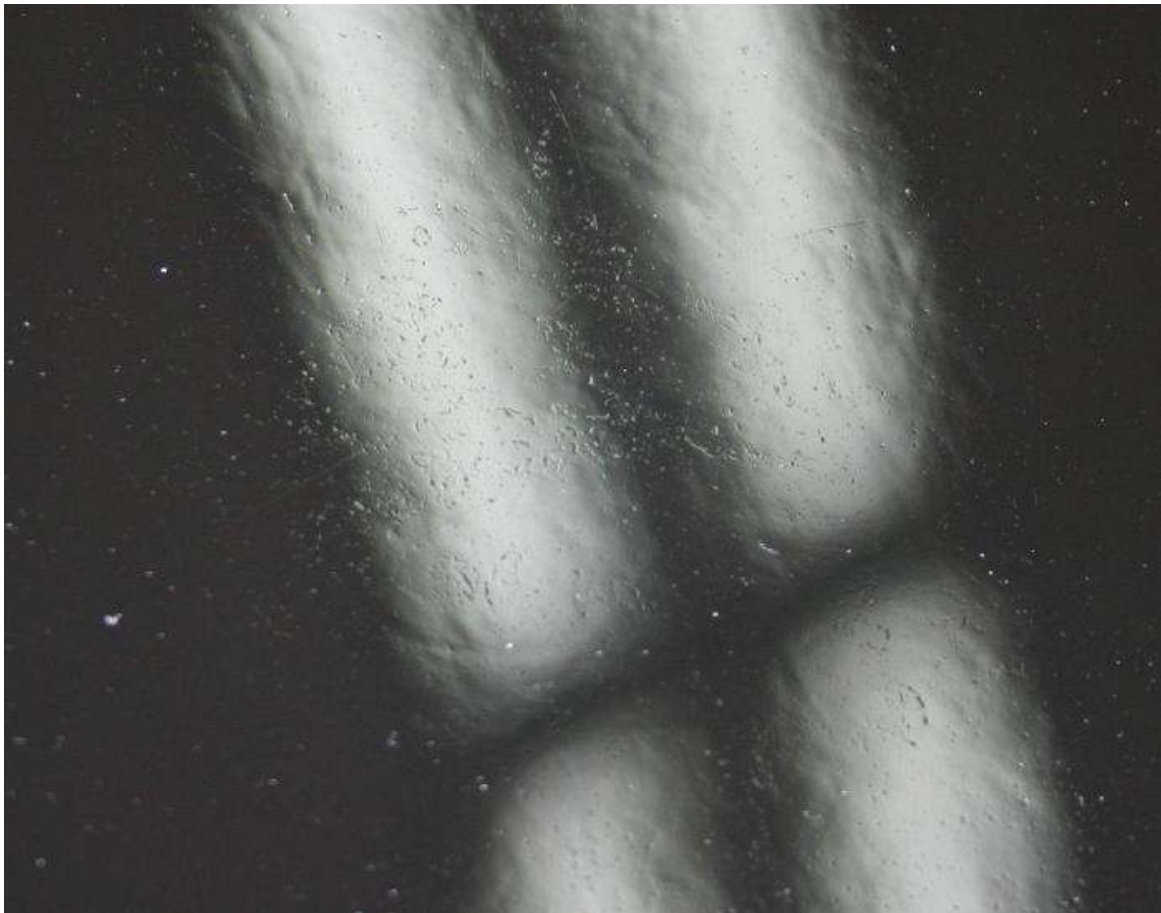
After

The 6.3 mega pixel camera, held about one foot away was able to capture what remains of the etching. The above photos are what are referred to as RAW format photos. That is they have not been altered or modified in any way, including resizing. They have been cropped out of the original at 700 pixels wide.

The after picture shows just a small amount of pitting, but not enough to continue removing clear coat from the finish because with your eyes up close, about one foot

away, you cannot see this pitting. Standing directly over the hood of the car and looking directly into the hood, you can see no sign of the original etching.

Below is a picture of the same defect after a thorough polishing and waxing procedure was performed by the owner using the following products. (Note: The below is a list of all the products used over the entire car including the etching left by the bird dropping.

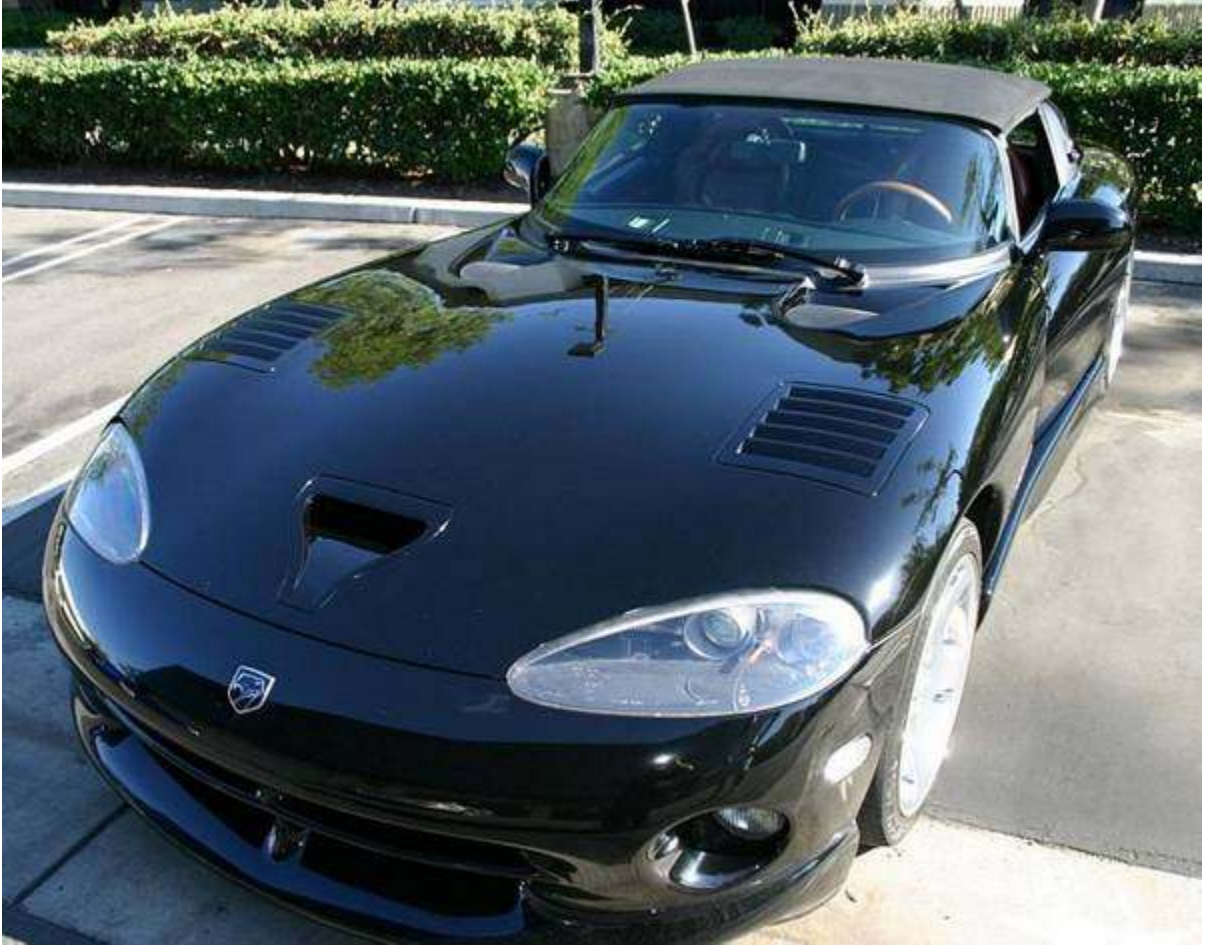
When were were all through, the defect was no longer visible unless you knew where to look, were in the right light, and put your face right down close to the finish.
